MERRIMACK RIVER BASIN
LACONIA, NEW HAMPSHIRE

AVERY DAM

NH 00465

PHASE I INSPECTION REPORT
NATIONAL DAM INSPECTION PROGRAM

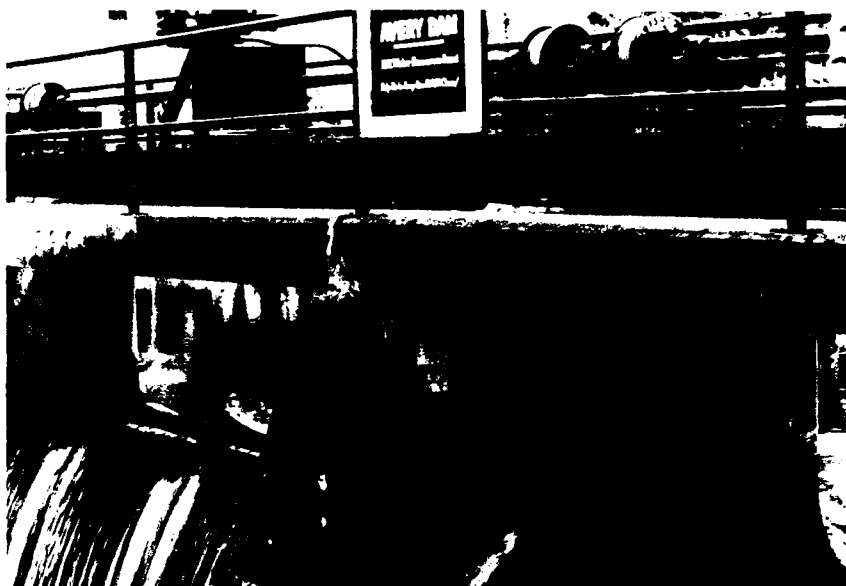
The concrete walkway is in fair condition. The walkway suffers from extensive cracking, spalling and efflorescence over the buttress dividing the hinged leaf gated spillways. Minor hairline cracking and associated efflorescence is also evident at the four reentrant corners of the walkway. The removable galvanized steel service gratings are in good condition.

3. View from downstream of open joint
in concrete service bridge

- (b) Repair the eroded slope revetment along the right training wall and monitor this area for future deterioration.
- (c) Repair all areas of cracked, spalled or eroded concrete, paying particular attention to the proper filling and sealing of joints and cracks.

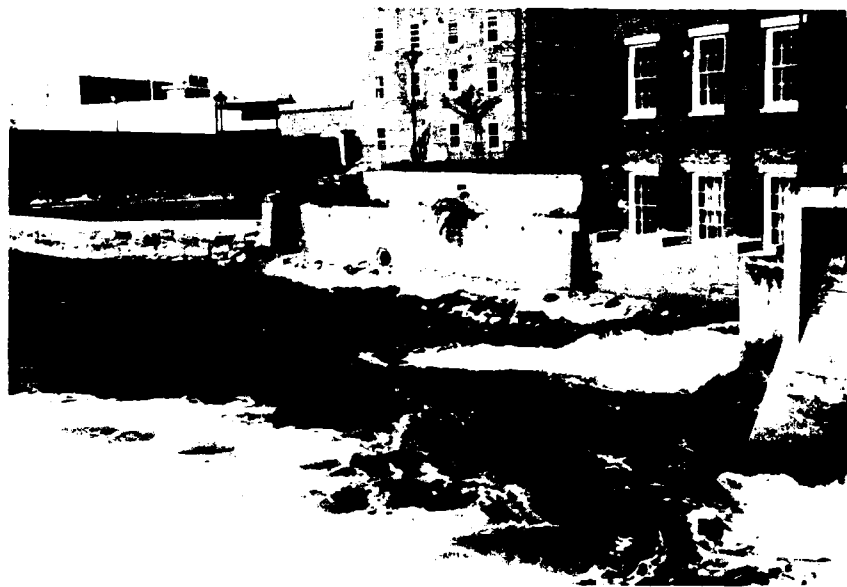
The concrete in both the front and back walls is in good condition. However, the slope revetment placed as toe protection adjacent to the front wall has been seriously eroded. Probing reveals that voids up to 6 feet in depth occur under the foundation of the front wall; approximately 6 feet of the front wall footing are exposed.

The erosion of the slope revetment along the right training wall presents no hazard to the dam, but requires attention to prevent potential undermining of the building foundations.

4. View from dam of erosion on right
side of downstream channel
